# Uniform Appraisal Dataset (UAD) Specification

## **Appendix D-1: Condominium Scenario (Condo1)**

# Uniform Residential Appraisal Report

201 UNDERHILL DR, UNIT 202, NOWHERE, CA 90021

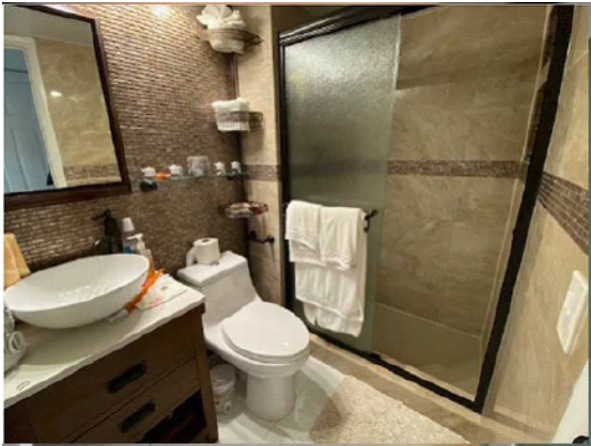
Level 1 - Bath - Full - Bath 1

| Room | Update Status | Time Frame | Quality Comment | Condition Status | Condition Comment |
|---|---|---|---|---|---|
| Bath - Full<br>Level 1 | Fully Updated | 1-5 years | Tile shower and custom vanity, owners utilized custom designer for tile work. | Typical Wear and Tear | Add comment if needed. |

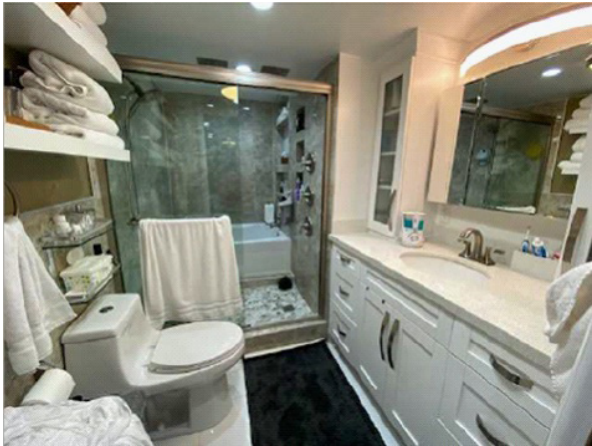
Level 1 - Bath - Full - Bath 2

| Room | Update Status | Time Frame | Quality Comment | Condition Status | Condition Comment |
|---|---|---|---|---|---|
| Bath - Full<br>Level 1 | Fully Updated | 1-5 years | Tile shower and custom vanity. | New or Like New | Bathroom rarely used, shows nicely. |

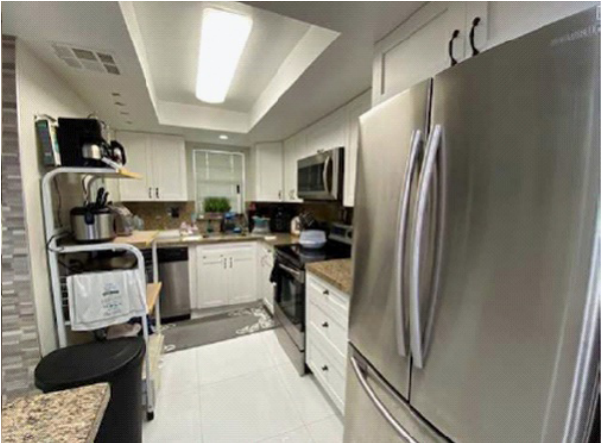
Level 1 - Kitchen

| Room | Update Status | Time Frame | Quality Comment | Condition Status | Condition Comment |
|---|---|---|---|---|---|
| Kitchen<br>Level 1 | Fully Updated | 1-5 years | GE Monogram appliances and hardwood painted cabinets. | New or Like New | Add comment if needed. |
